Manhole Inspection Summary

Manhole # S09KK1022MH

Insp Date: **5/17/07 12:08 PM**

Location Address: **3313 VIRGINIA AVE**

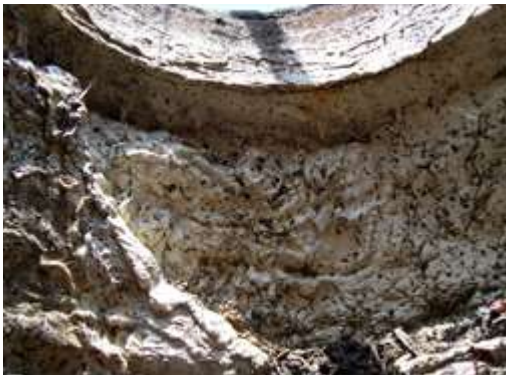
Defect 1

Condition: ☐ Sound ☐ Cracked ☐ Root Intrusion ☐ Loose Brick ☒ **Deteriorated**

CONE DETERIORATING

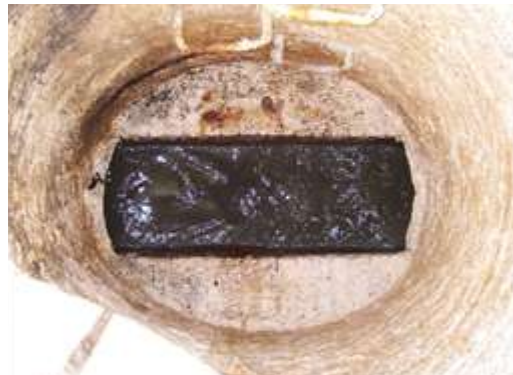
Defect 2

Steps Count: **5** Missing: **0** ☒ **Corroded**

Surcharge ☒ **Evidence Of Surcharge** Depth: **7.5** (ft.) ☐ Active Surcharge Present

CORRODED STEPS AND SURCHARGE EVIDENCE

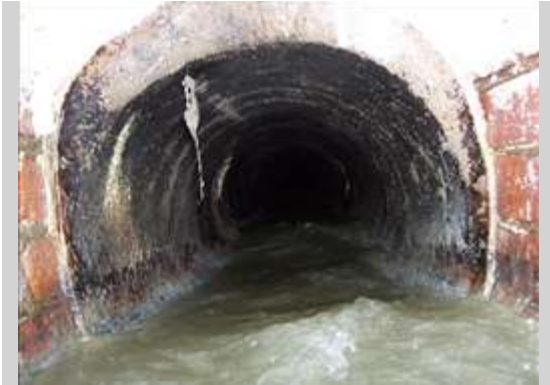
12 O'Clock Outflow

18 in. Circular Gravity Sewer
Pipe Out @ 12 O'Clock

Pipe Height: **18** (in.) Rod and Bar (Angled)
Pipe Material: **PVC** ☐ Pipe Lined
Invert Depth: **10.42** (ft.) Flow Characteristics: **Fast**
Deposits: ☒ None ☐ Mud ☐ Sludge ☐ Debris ☐ Grease
Silt Depth: (in.) Deposits Extent:
Infiltration: **None** Pipe Seal Cond: **Sound**

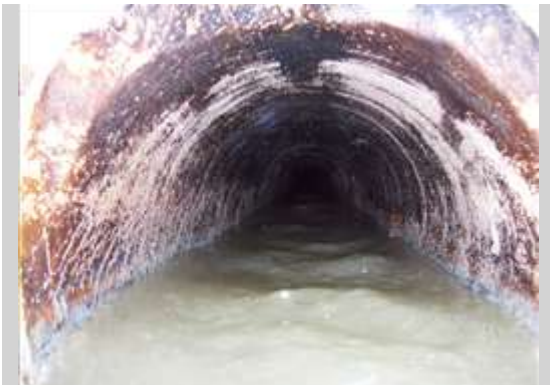
6 O'Clock Inflow

18 in. Circular Gravity Sewer
Pipe In @ 6 O'Clock

Pipe Height: **18** (in.) Rod and Bar (Angled)
Pipe Material: **PVC** ☐ Pipe Lined
Invert Depth: **10.30** (ft.) Flow Characteristics: **Fast**
Deposits: ☒ None ☐ Mud ☐ Sludge ☐ Debris ☐ Grease
Silt Depth: (in.) Deposits Extent:
Infiltration: **None** Pipe Seal Cond: **Sound**
